**Flood Control Project Maintenance
Levee Inspections****LMA District Cover Sheet****Spring 2014 Levee Inspection Results****Reclamation District No. 0017 Mossdale**

Spring 2014 Levee Inspection Results

Reclamation District No. 0017 Mossdale

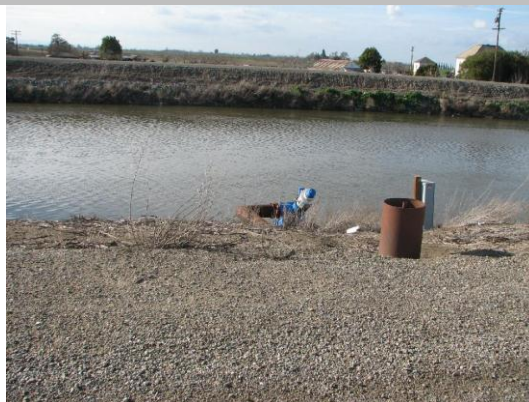
Photo 1 of 1 : UCIP_3211.jpg

LM Start	2.06	Rating **	M	Issue No.	35
LM End	2.06	Issue Type +	En	Location *	WS
Category	Supplemental			GPS Latitude/Longitude	
				Start	End
Item	DWR UCIP Field Study			37.889477 °	37.889477 °
				-121.328766 °	-121.328766 °
DWR ID	DWR_RD0017_02_s_2014_35

FS Date: 2/4/2010
